## SELF-GUIDED HIKE TO FOURMILE CANYON CREEK FLOOD DEPOSITS AND CHANGES TO THE LANDSCAPE

Sue Ellen Hirschfeld, Ph.D.

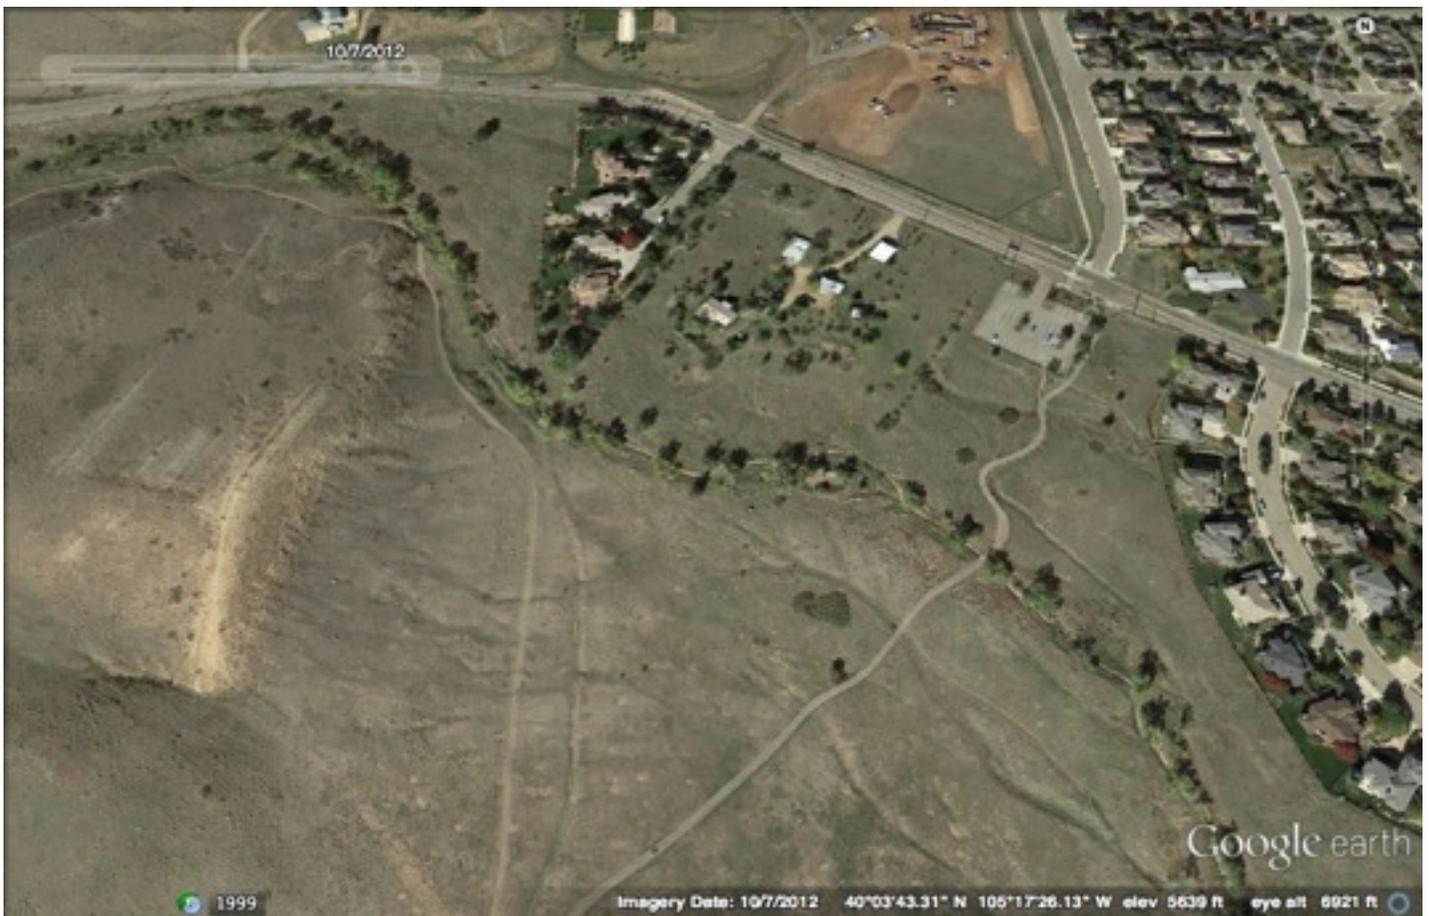
The Four Mile Creek trailhead parking lot is the gray square right of center. Pre-flood location of Fourmile Canyon Creek is outlined by the trees. Old drainages can be seen. Compare with post-flood photograph on next page.

After the flood, the course of the creek and the floodplain were changed dramatically. Compare this photograph with the previous one as you follow this guide. You will cross two channels eroded by the 2013 flood that can be seen as shallow depressions in the pre-flood photograph above.

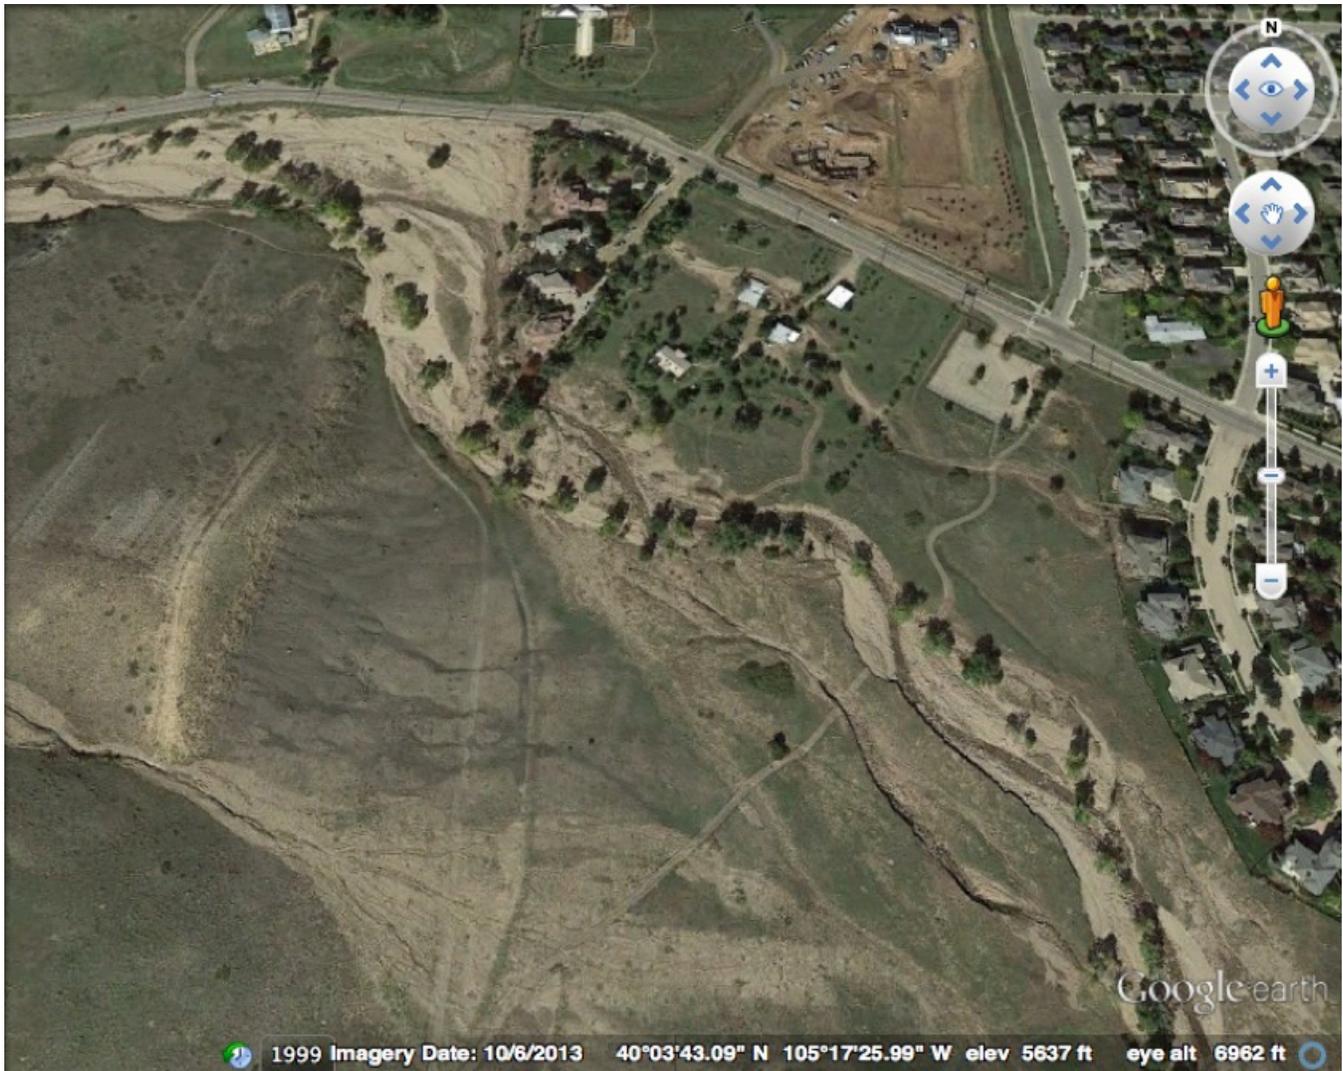
Photograph of the floodplain and creek after the September 2013 flood.

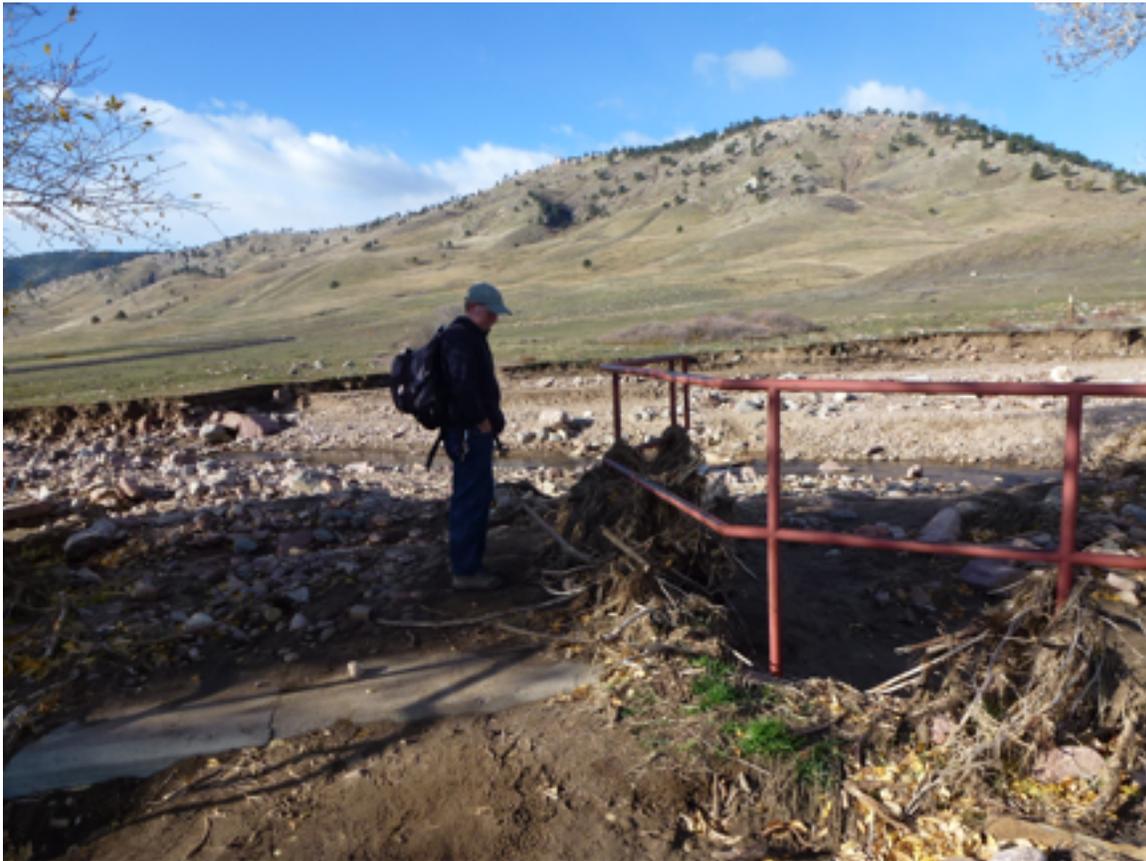
Bridge to “nowhere” and debris collected by the bridge in the September 11-13, 2013 flood.

Pre-flood estimates for a Fourmile Canyon Creek 100-year flood are about 3,300-3,500 cfs (cubic feet per second). The 2013 flood may have exceeded this flow. To put this in perspective, the maximum volume of water flowing down Boulder Creek in Boulder reached about 5000 cfs. An estimated flow for Fourmile Canyon Creek is close to 4000 cfs in the September 2013 storm. More sustained rainfall over this drainage basin and the burn scar from the 2010 Fourmile fire may have contributed to the dramatic deposition and erosion across this entire floodplain.

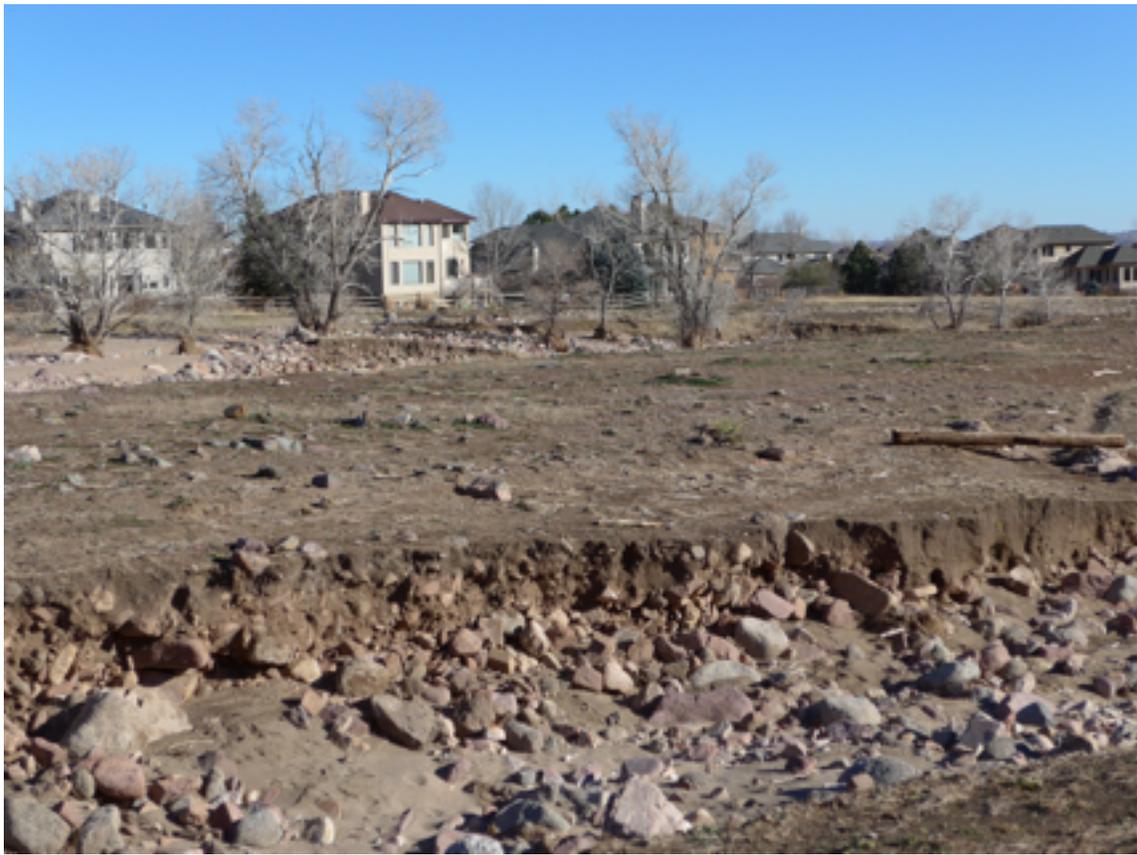
Newly carved channel by the September 2013 flood. Large rounded boulders from an older flood are exposed.

The walls of the new channels show evidence of earlier, larger floods. Look for some very large boulders under a dark soil. It takes hundreds to thousands of years to form dark, organic-rich soil. Starting with clean sand after a flood, organic matter very gradually accumulates to form soil. Between the two channels, boulders from the older flood deposits are sticking out at the ground surface. The 2013 flood reworked the boulders and sand from the older flood deposits. Some of the sediment was carried by the flood from the burn area.

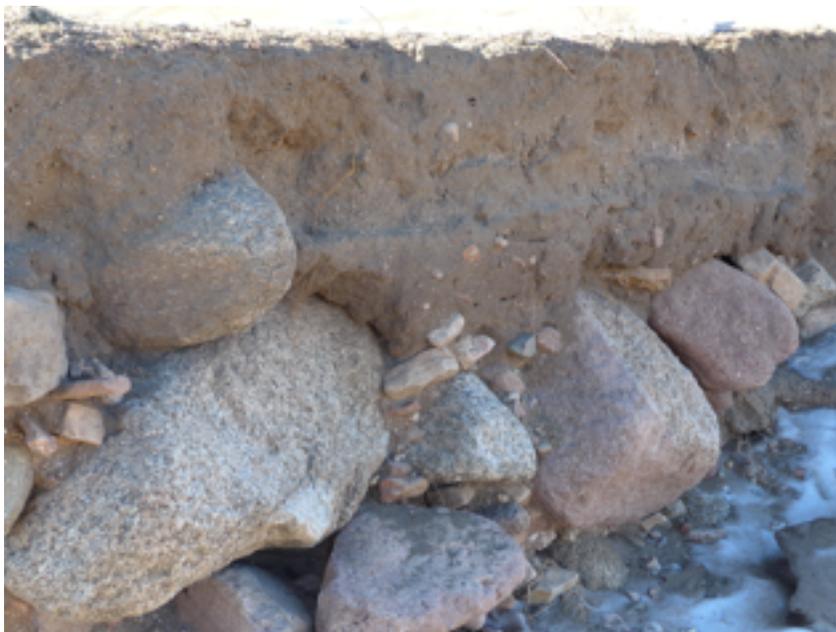
*Close-up of older flood deposits with large rounded boulders and a well-developed soil above them.*

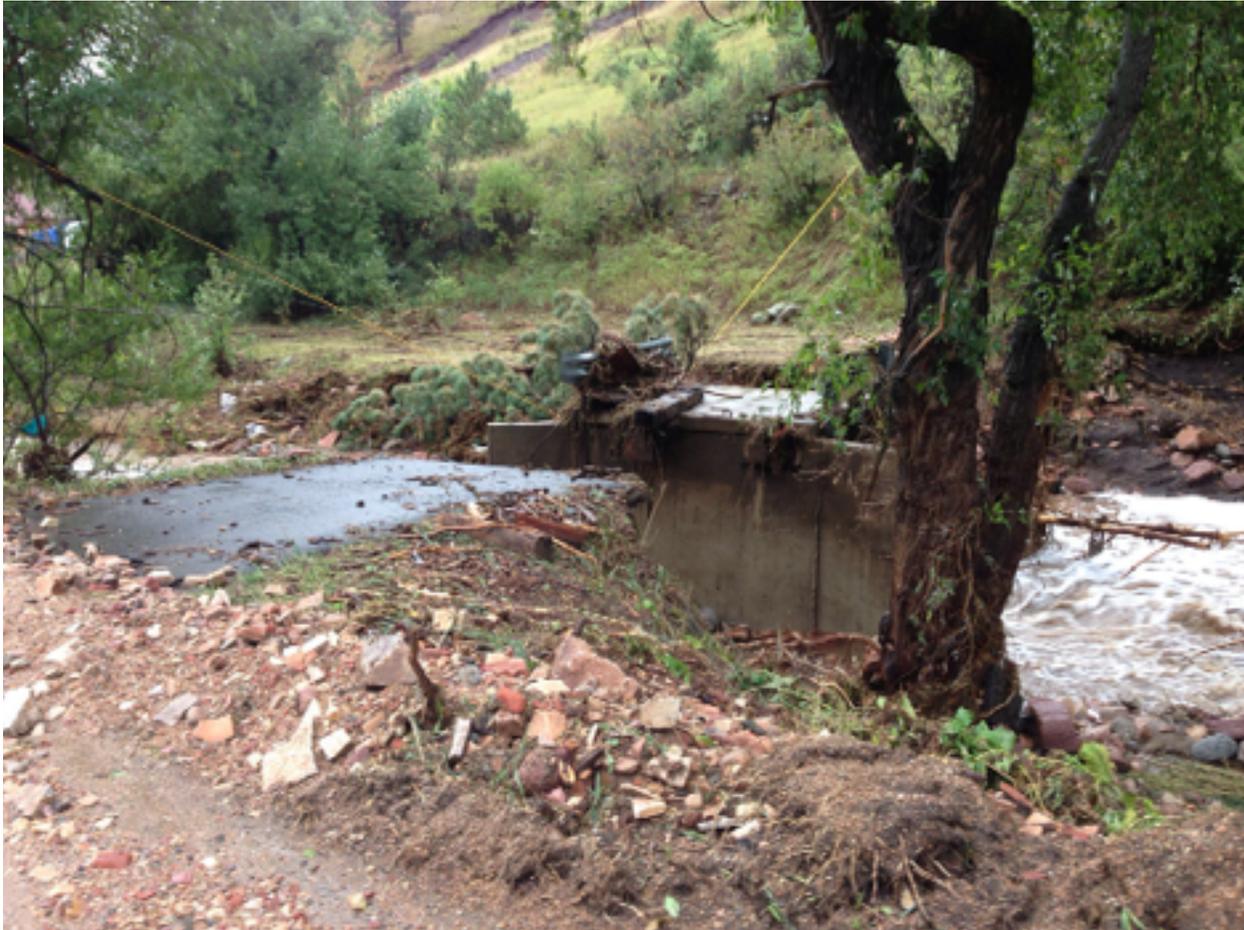
Bridge destroyed at “choke point” along Lee Hill Drive. Note the vegetation on the bridge deck indicating how high the flow was here (photograph taken September 15, 2013 by James V. Holmes).

The height of the flow along Lee Hill Drive can be estimated near a “choke point” where the canyon narrows and the remains of a damaged bridge has debris caught on the deck. This photograph shows that flood water was flowing over the top of the bridge. Just downstream, flood water flowed across Lee Hill Drive where it carried and deposited sand and gravel on the north side of the road. On the south side of the road flood water covered and buried the trailhead parking lot with sand.

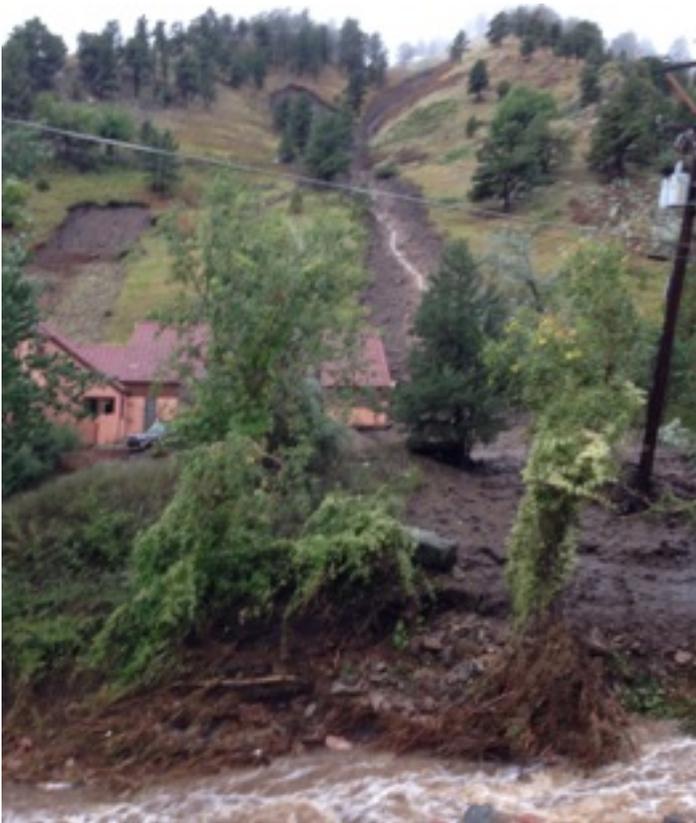
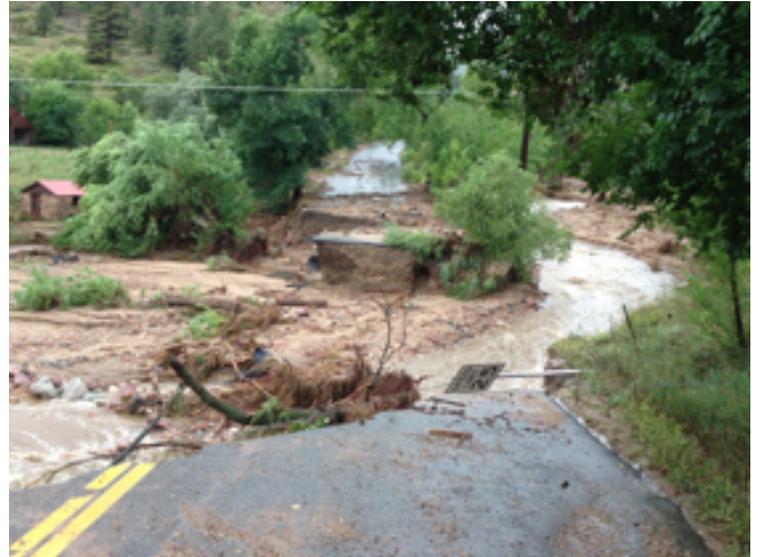
Erosion of Wagon Wheel Gap road

Two landslides contribute sand and rock debris to the floodwaters (Photographs by Jamie V. Holmes).

A large amount of the sediment and debris was contributed from hill slopes that had been undercut, and from landslides (photograph below).

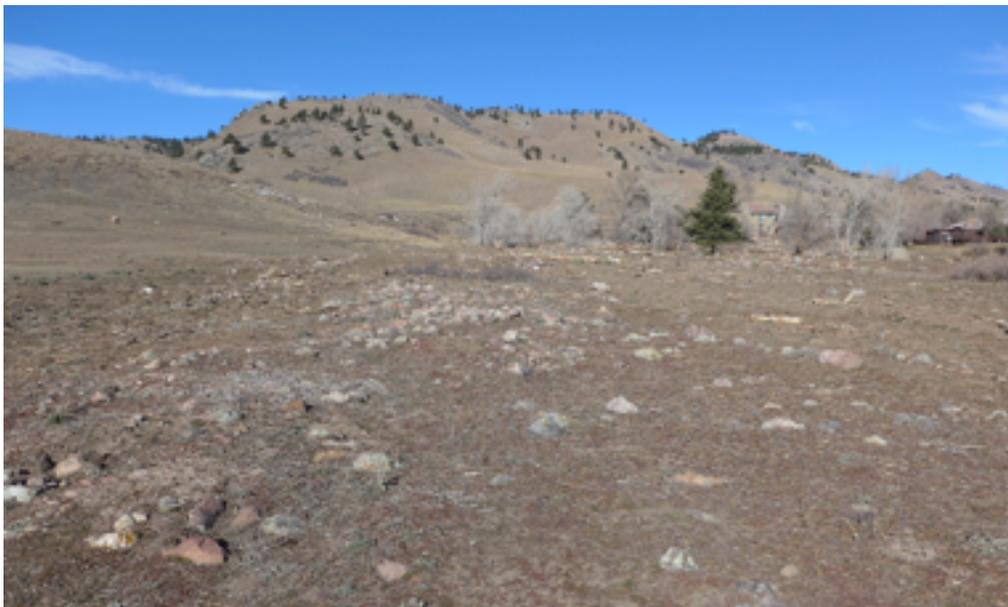
Boulders from an older flood deposit are exposed on the north side of the trail south of the creek. This area had flood water carrying logs and wood flowing over it in 2013. Note how far this is from the pre-flood channel.

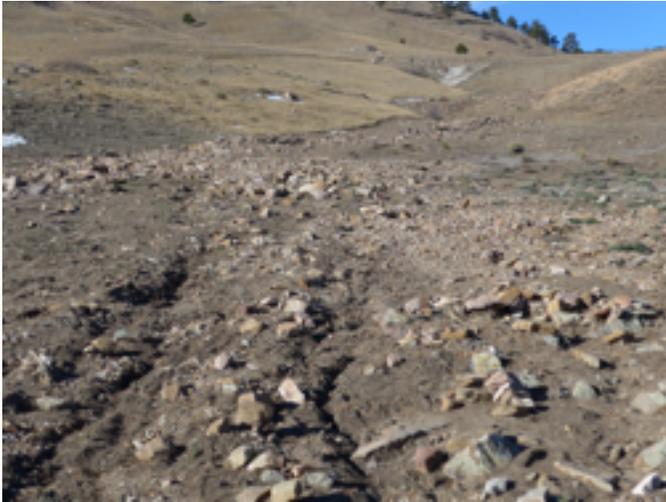
Scattered rocks from the debris flow from Dakota Ridge.

You are walking across the debris field from a large landslide that started high up near the top of Dakota Ridge and flowed down across the trail. Farther along the Old Kiln Trail there are better views of where this slide started. What is interesting to observe here is the rock debris surrounded by mud. This slide contained a lot of water and was quite fluid as it moved. When it reached this section of the trail, most of the larger rocks stopped moving and the mud kept flowing downslope until it reached a low berm where it stopped.

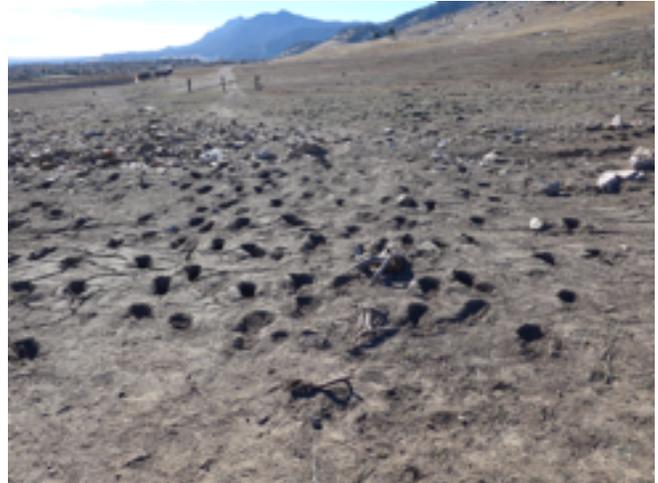
Footprints in mud that drained from the slide.

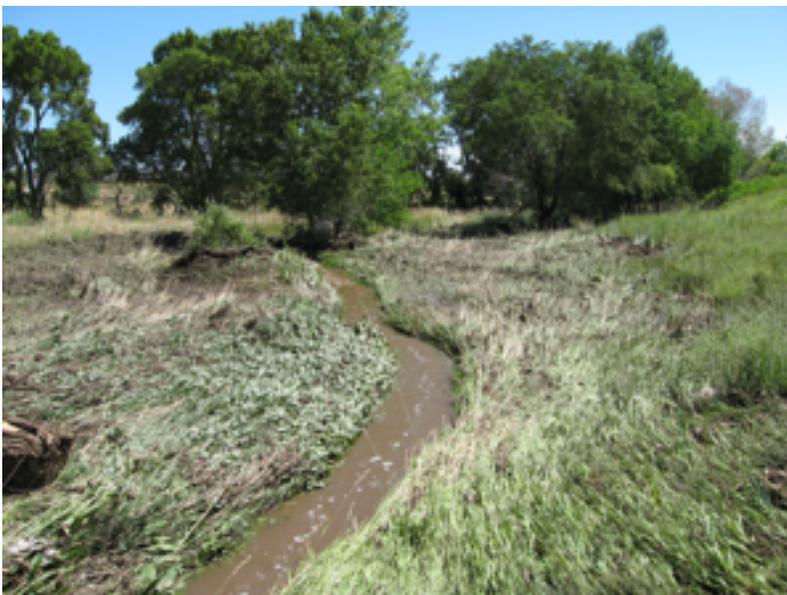
Height of flood water during 2011 flood. Note that sand and boulders were not carried downstream by the flood water.

About a third of the drainage basin of Fourmile Canyon Creek was burned in the Fourmile Fire in 2010. On July 7th 2011, a big thunderstorm produced a small flood that came down Fourmile Canyon Creek and overflowed the channel (photo). It is interesting that there was not sufficient flow to carry and deposit sand and move large rock debris.

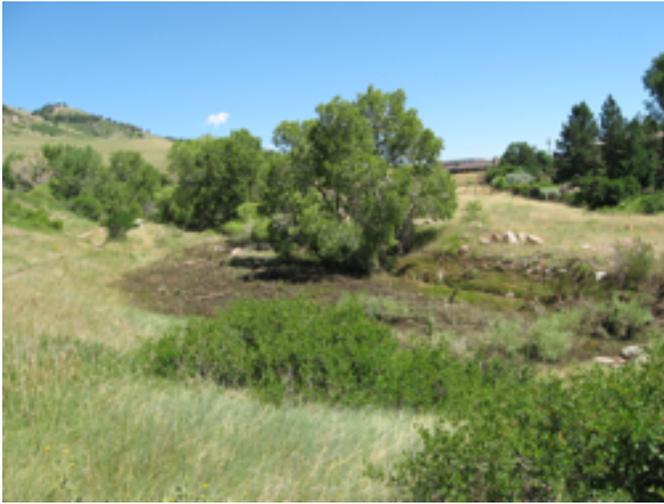
No deposition of sand in the 2011 flood.

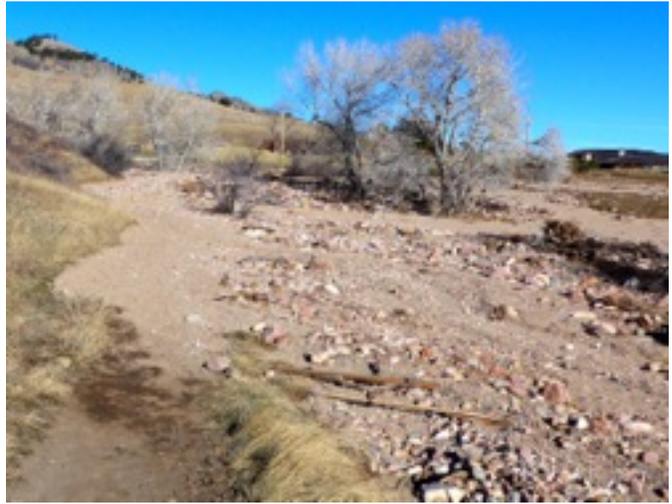
Sand and rock deposited during the 2013 flood.

The area on the right image has been modified by a new rock-lined channel excavated in 2014 to prevent flooding of homes close to Lee Hill Drive.

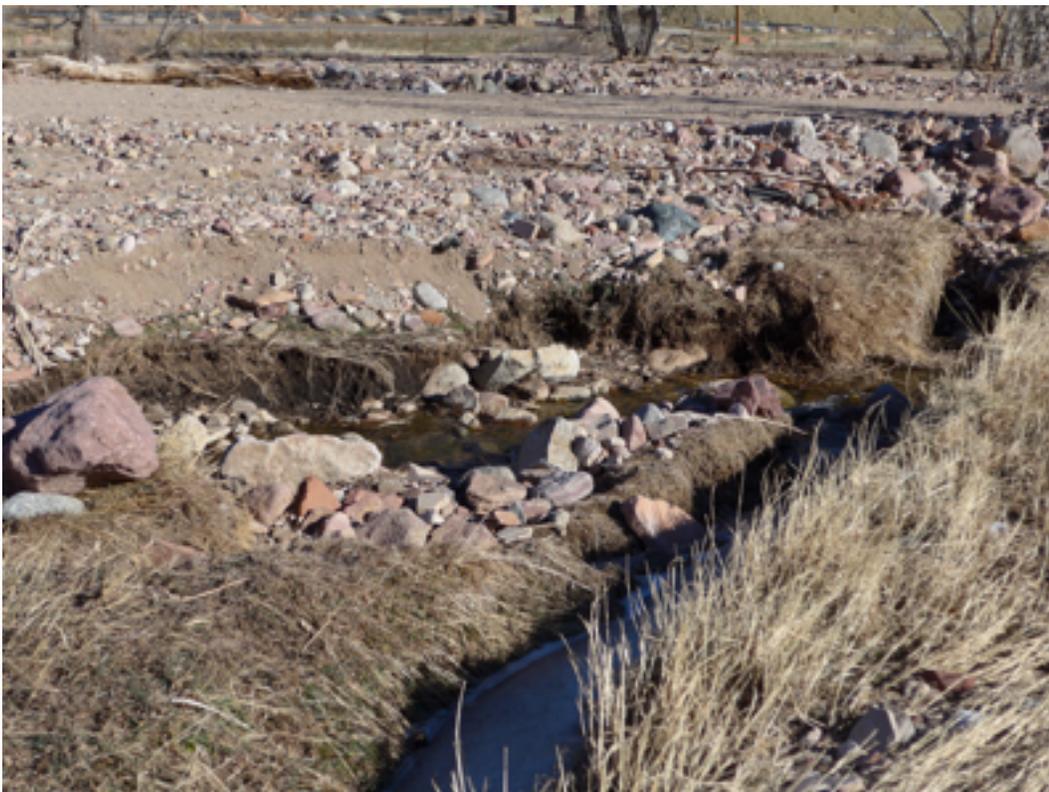
Note how boulders have been moved onto the grass in the foreground and on top of the sand in the background.

The tremendous power of the flood water can be seen along the trail where a collection of boulders has been deposited on the pre-flood grassy slope.

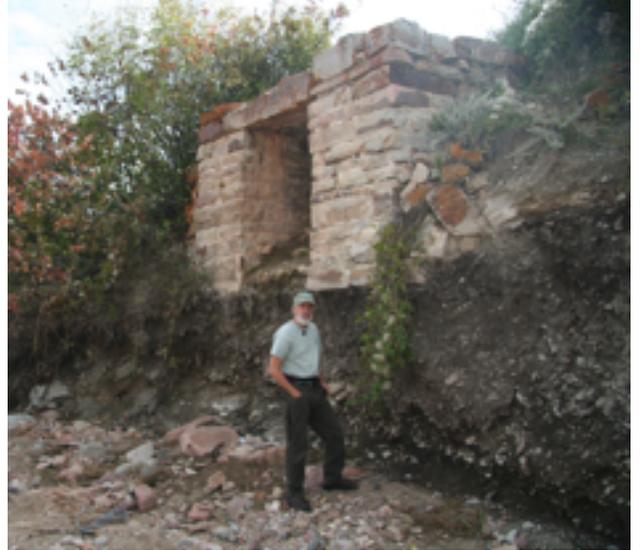
Depth of erosion caused by the 2013 flood.

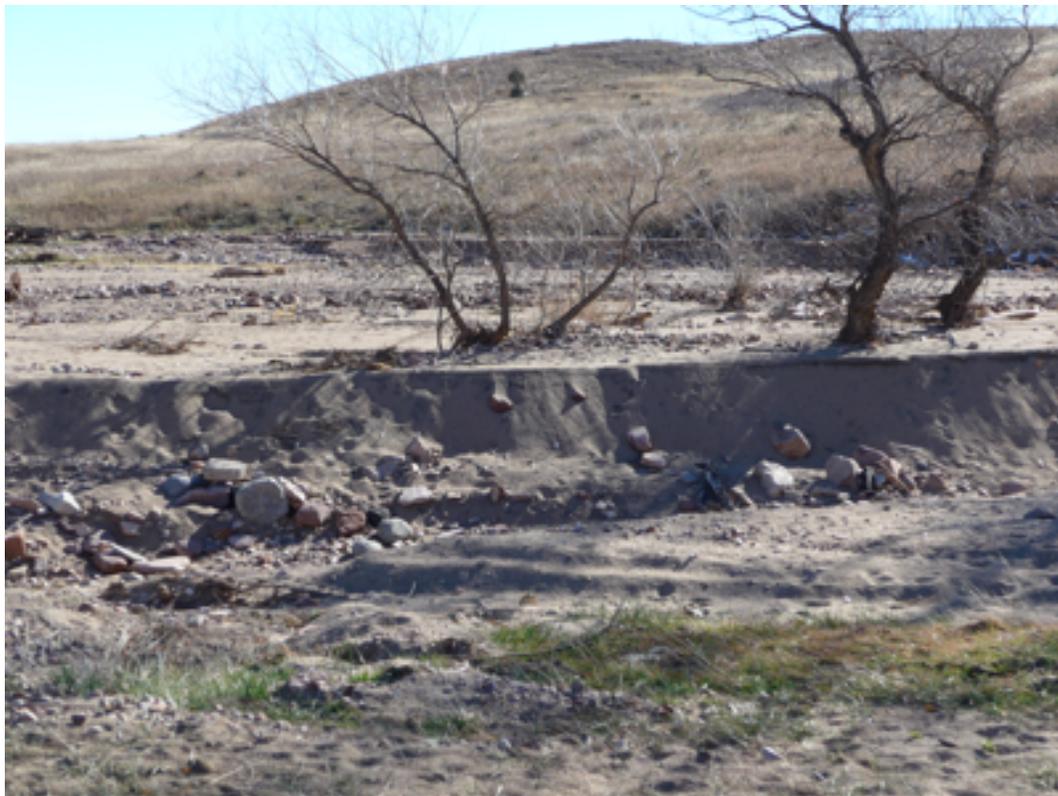
Photograph taken from Lee Hill Drive looking south. Huge amounts of sand were deposited by early surges of flood water. Later surges excavated these deposits and moved larger boulders and debris.

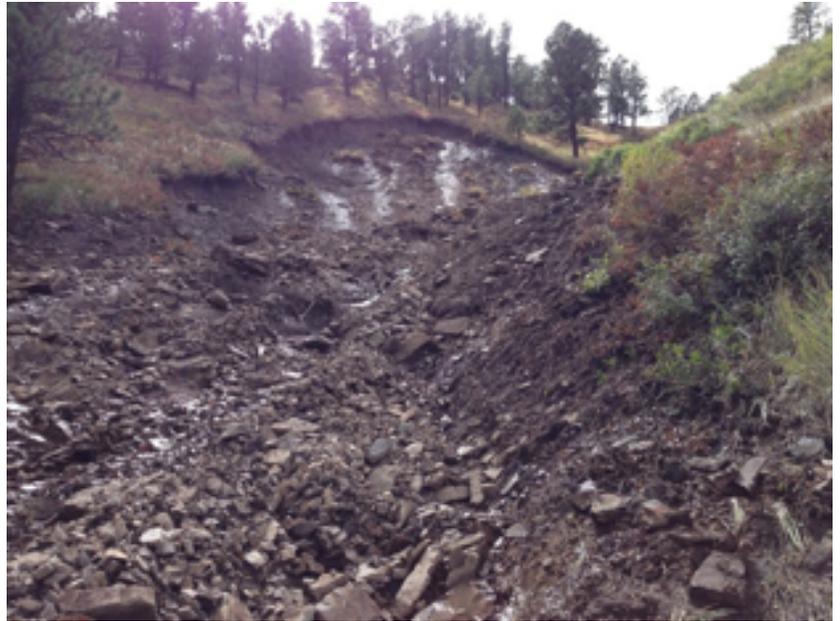
Head of landslide starting near top of Dakota Ridge (Photograph by Barbara Dobbs).

*Walk to the south end of the split rail fence where the layers of white rock (Fort Hays Limestone) are exposed. On the slope below, notice the scar of the big landslide that you walked across on the trail below. Head scars and debris trains of other landslides are apparent.*

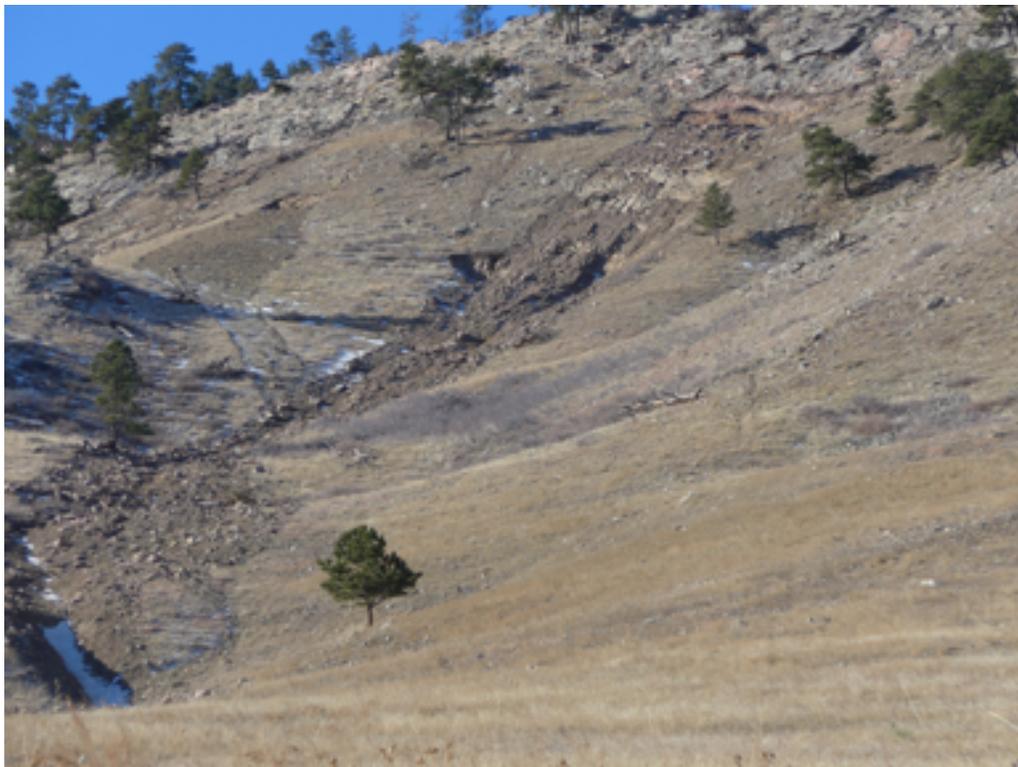
Landslide scar above Fort Hays Limestone

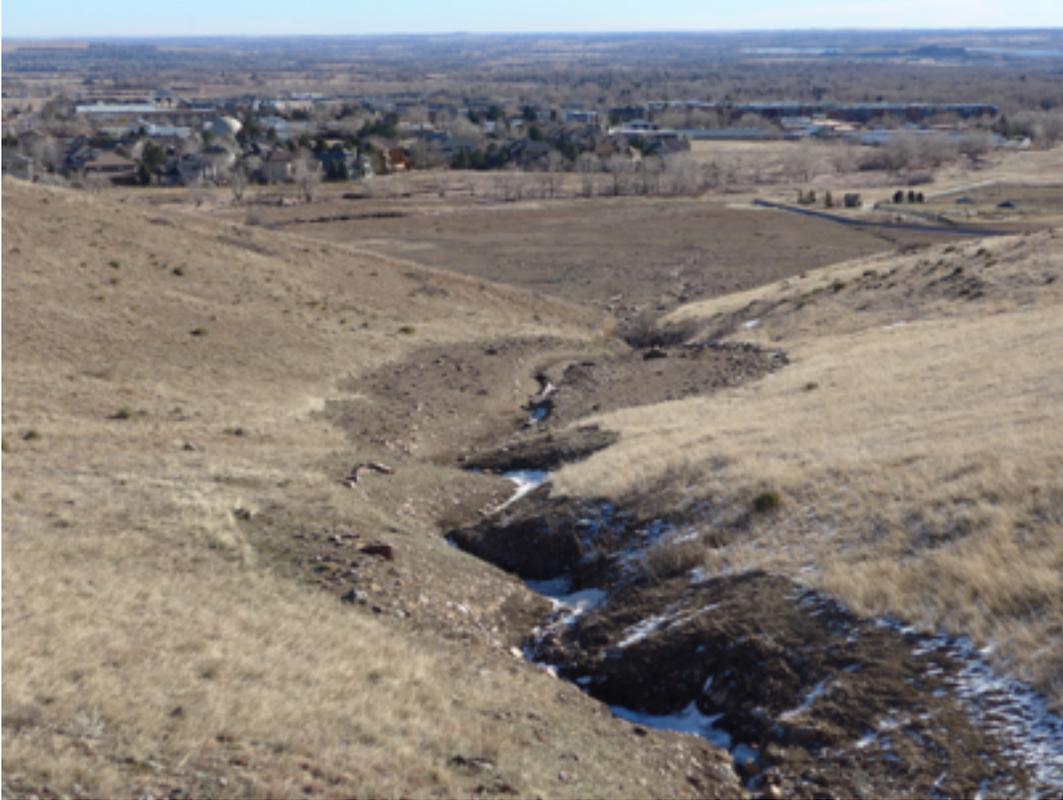
Landslide scar below  
Fort Hays Limestone
